# 406MHz ELT's and 406MHz Antenna's

Lloyd Klee  
[www.aviationsafety.co.nz](http://www.aviationsafety.co.nz)

# Reasons as to failures

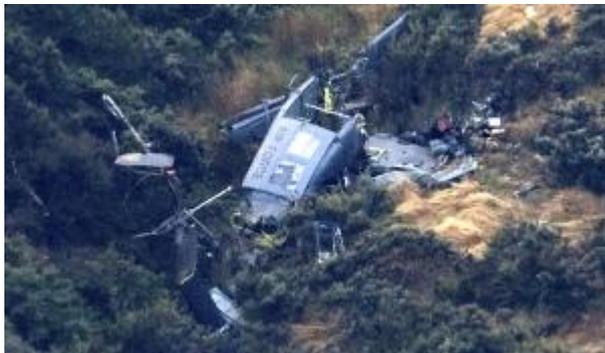
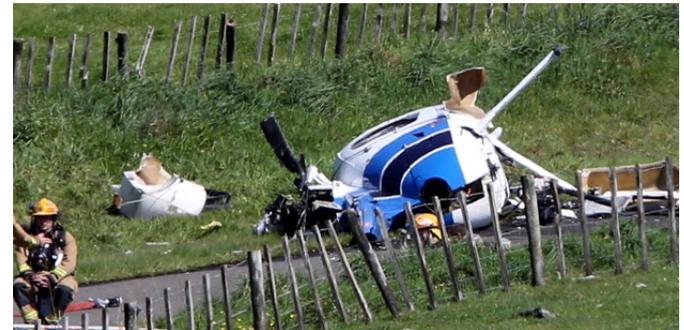
One of the major issues is the location of the Antenna

- Many are installed on the side of the helicopter – **Which side?**
- ***The side that the helicopter naturally lies on due the torsional rotation of the blades***

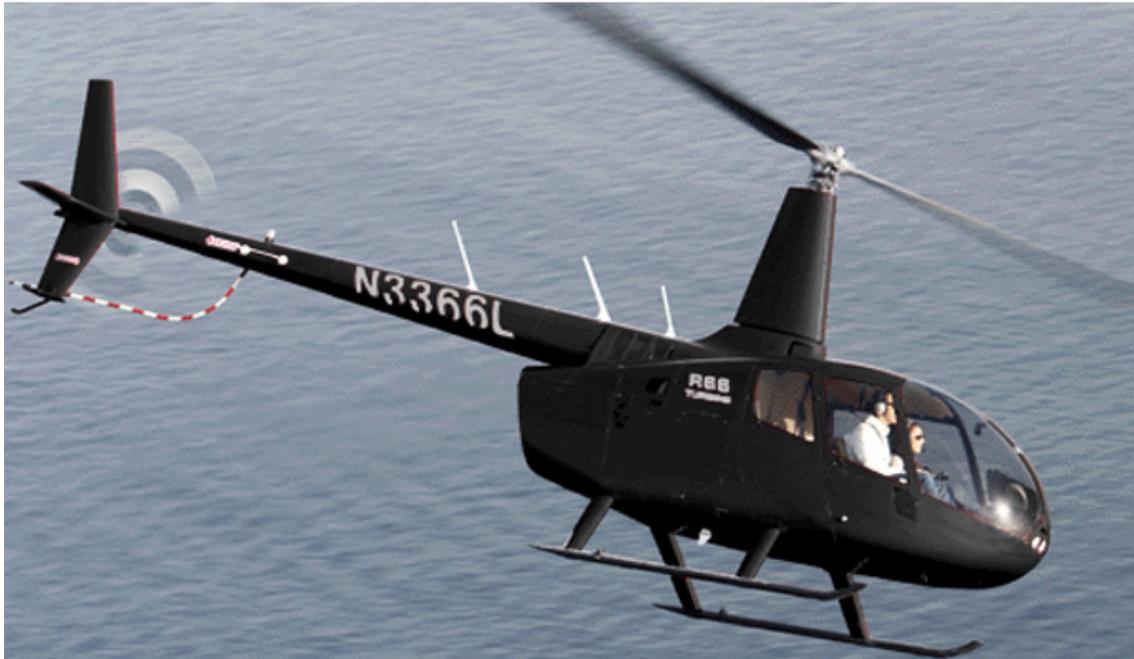
The rest are on the top and just as vulnerable

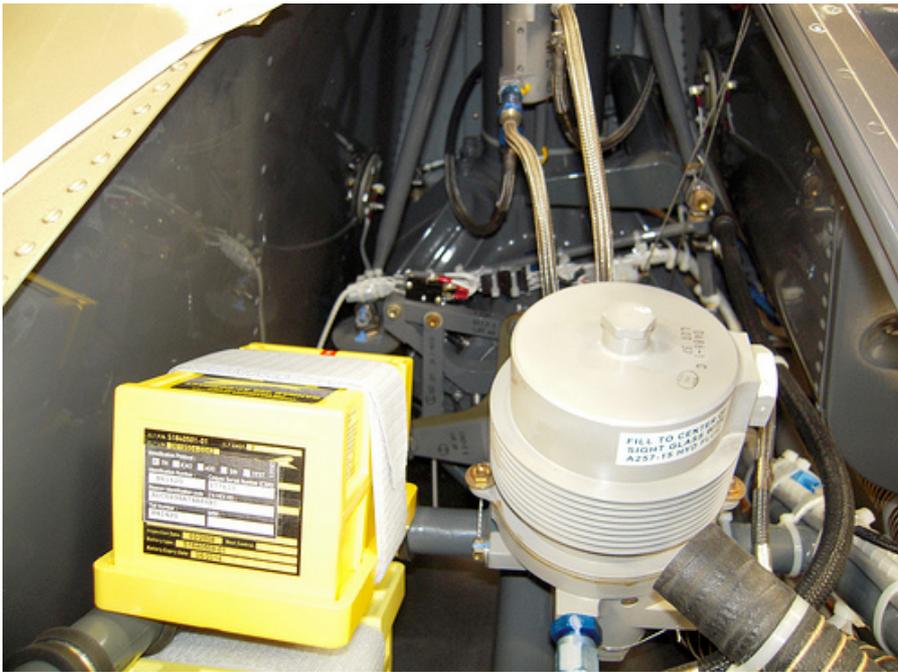
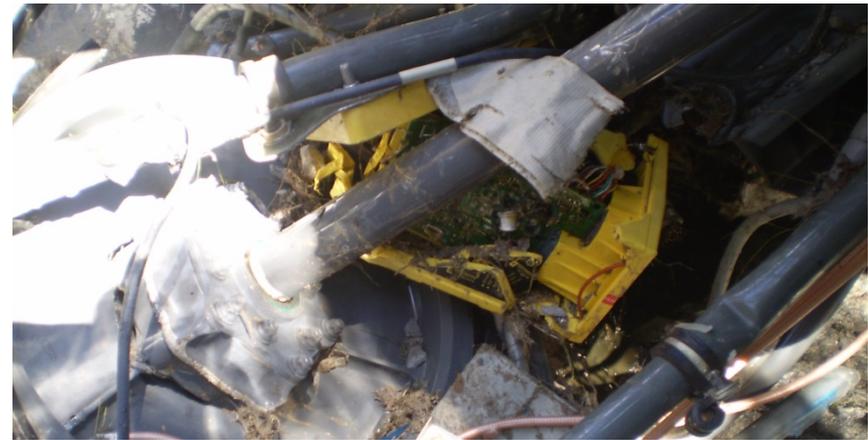
Then there is the issue with the location of the ELT !

The main mast to the rotor can crush the ELT especially if it is a R22 or R44

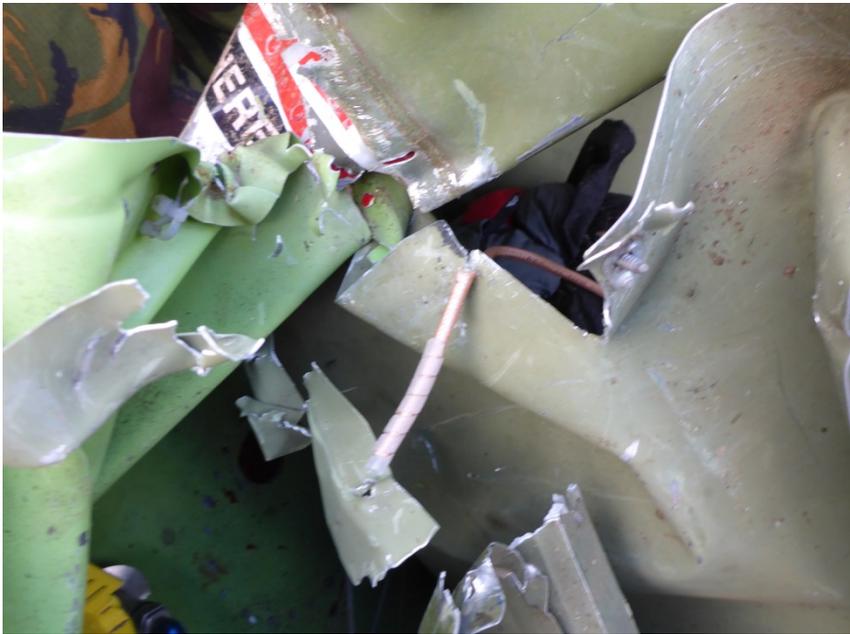
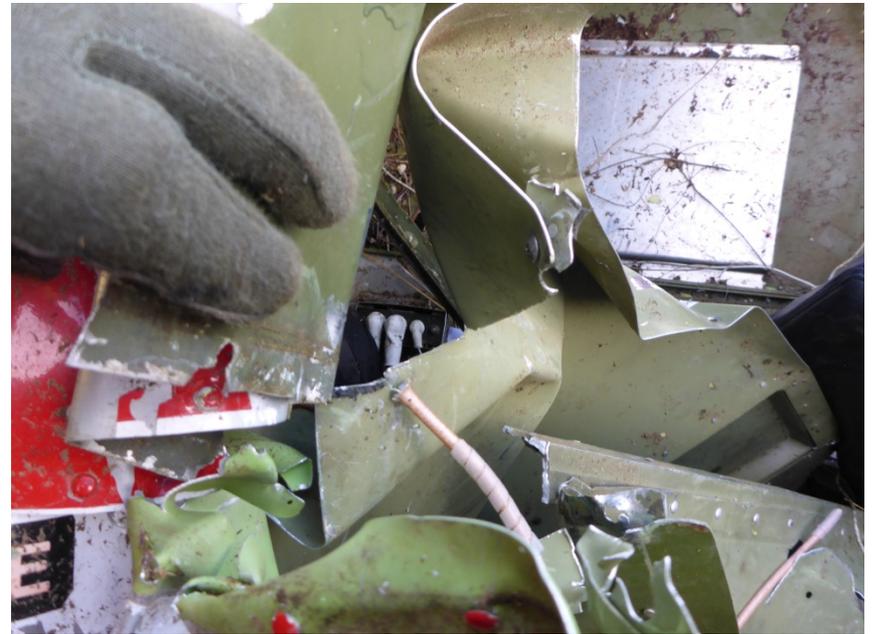
## The new cable “stripper”

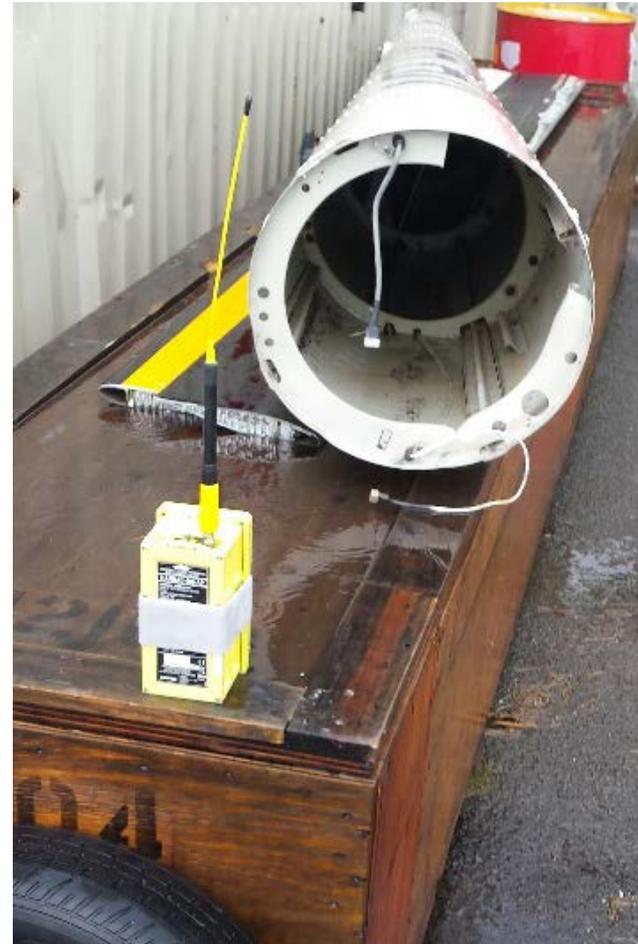
- Check BT100 2015- 043
- Power measured BT100 = 35.2dBm
- Power receipted on GEO satellite
- -134.55 dBm average

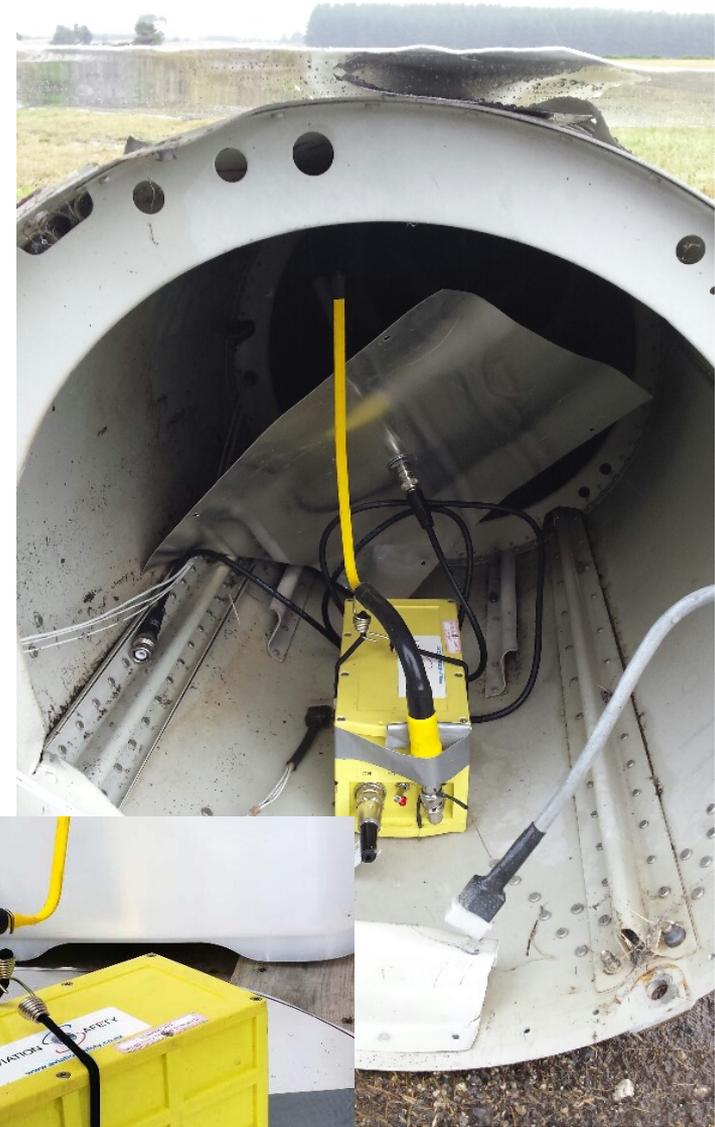
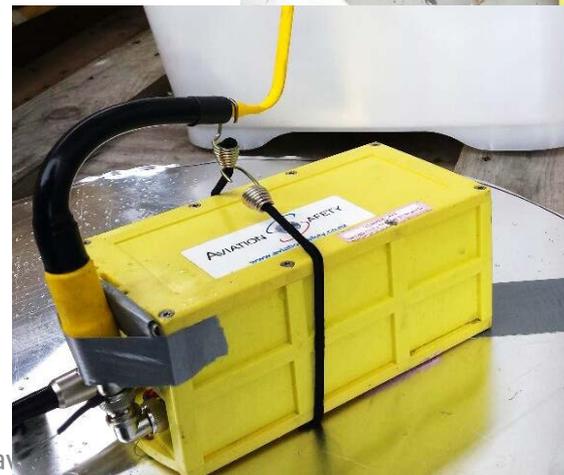
406AP- Vertical Antenna bent in “h” shape to fit boom then boom enclosed

External Radiated power measured BT100 2015-045 = **43%**

Power measured on LEO satellite

-138.23dBm average

This test was also successfully repeated with a whip antenna enclosed in the tail boom

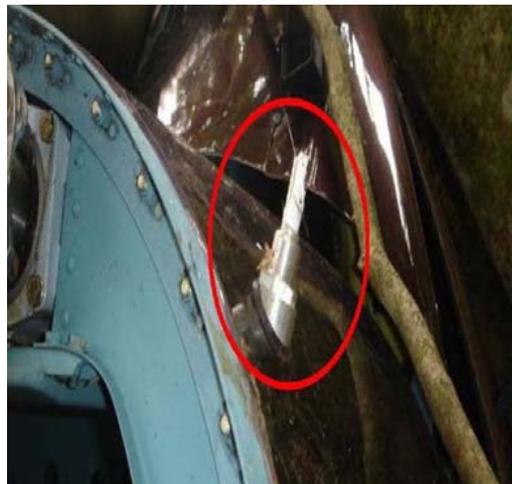
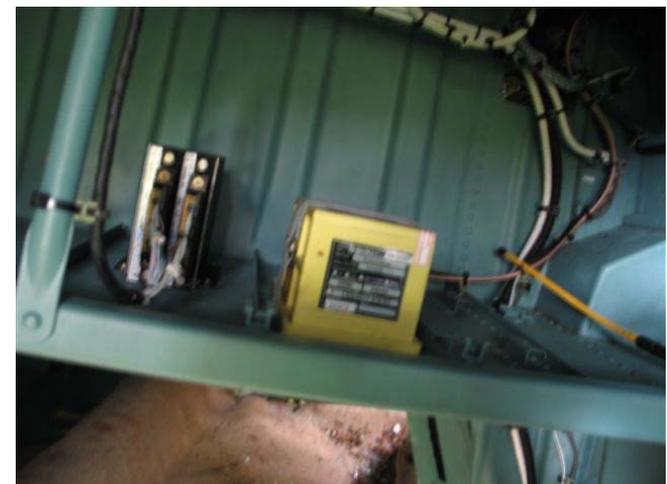
- ***Engineers will be able to install 406MHz ELT systems in the most crash worthy position and still comply with regulations***
- ELT systems currently fail due to regulations that prevent ELT antennas being placed in a

crash worthy  
position
