RC102 Remote Control Panel**Unintentional activation of self-test on RC102 RCP****1. PLANNING INFORMATION****A. Effectivity**

This Service Bulletin describes the procedure to modify the installation of RC102 RCP wiring.

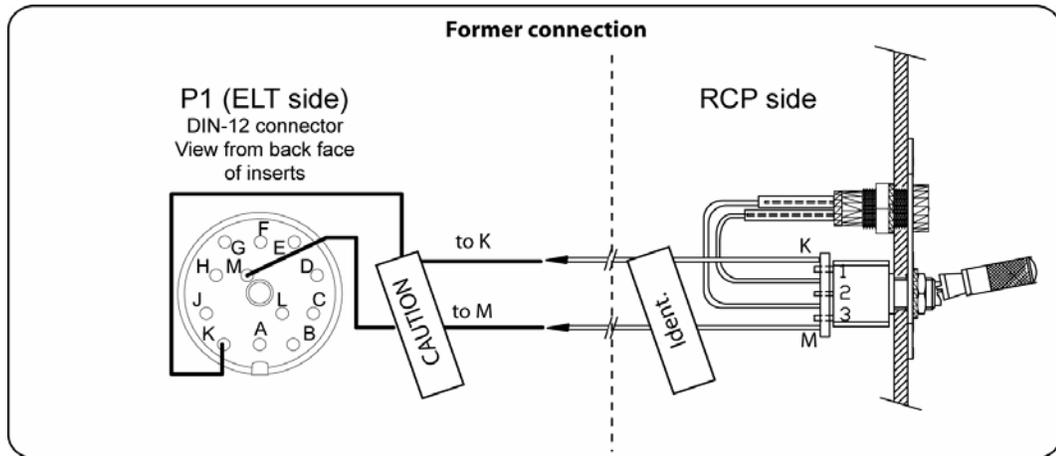
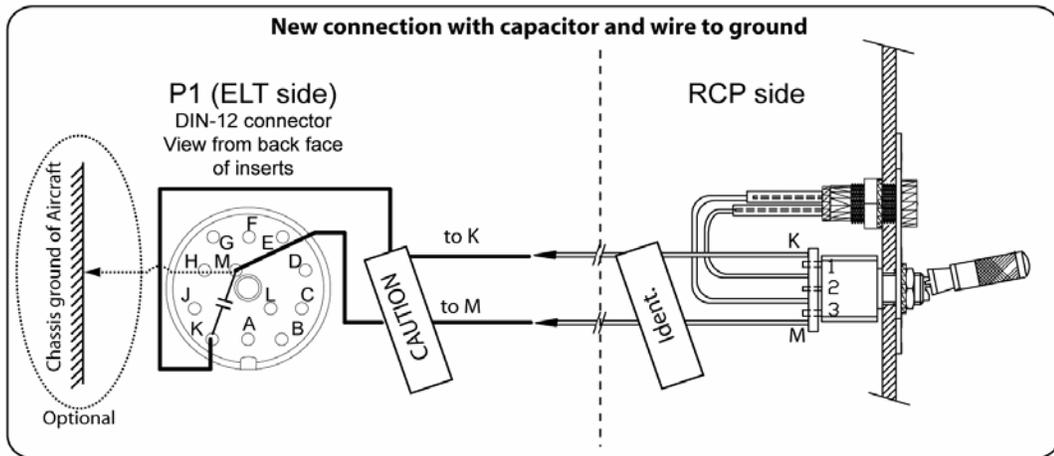
Figure 1: Diagram of connection

Some RC102 RCP installation may be sensitive to electrostatic influence when they are installed on certain aircraft. This default may be detected after the first installation when powering on or off the main power supply of the aircraft or any electrical circuits.

In this case, the ELT may perform unintentional self tests.

If the installation is affected by the default, the ELT will perform self-test visible by a temporary switch ON of the RC102 led.

This problem can be solved by soldering a 100 nF capacitor between pin M and pin K in the DIN-12 connector of the ELT and eventually connecting pin M of the DIN-12 connector to the chassis ground of the aircraft as close as possible to the ELT.

- (1) Disconnect DIN-12 connector on the ELT side.
- (2) Disassemble the DIN-12 connector supplied with the ELT.
- (3) Solder the 100 nF capacitor between pin M and Pin K of DIN-12 connector.
- (4) Reassemble the DIN-12 connector.
- (5) Connect the DIN-12 connector to the DIN-12 receptacle of the ELT.
- (6) Check the installation by following the procedure described in [Section C. Reason](#).
- (7) If unintentional self-tests still occur, an **optional** additional wire must be connected to the chassis ground of the aircraft.

IMPORTANT: the optional additional wire has to be soldered to the leg of the capacitor.
