Trials Classic Flyers October 2014

Experimental 406MHz Antenna Location testing within the confines of a helicopter tail boom

Auxiliary Antenna Trials, 15 May 2006

ACTUAL TEST of SASD 12 February 2009

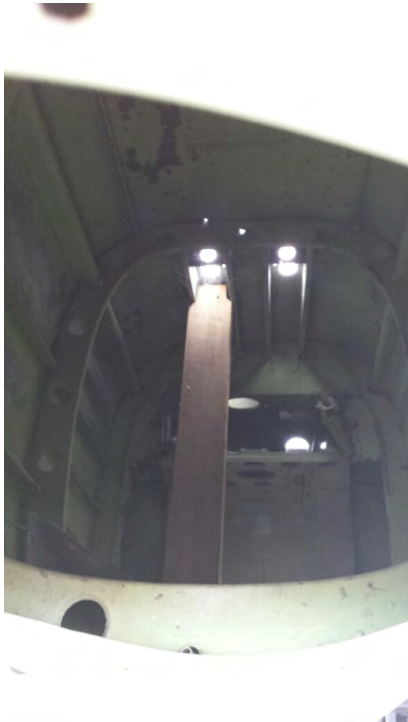
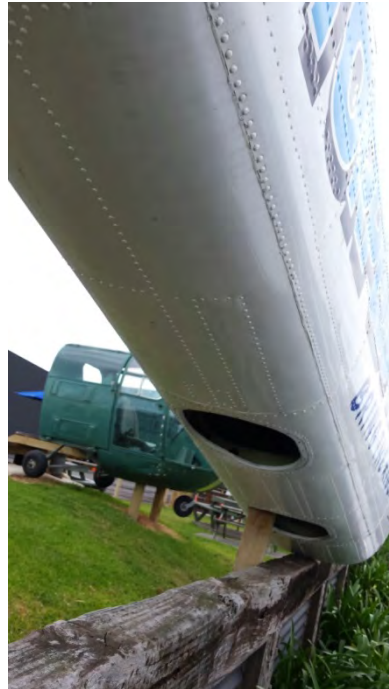
Holes in top of tail boom were covered with aluminium tape.
The closest inspection hole to the camera was covered
Tests were above the port lowest (closest to fence)

The airframe had most holes that were within the immediate vicinity of the operational antenna blocked off. Antenna transmitted through the aluminium structure successfully

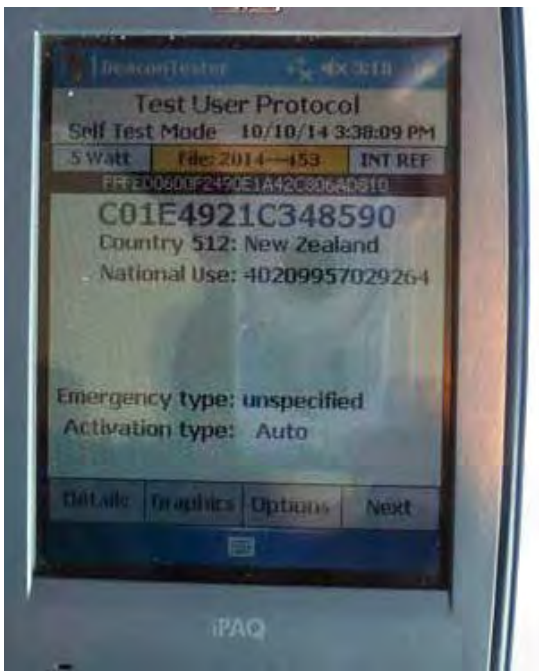
Test 02 2014-453

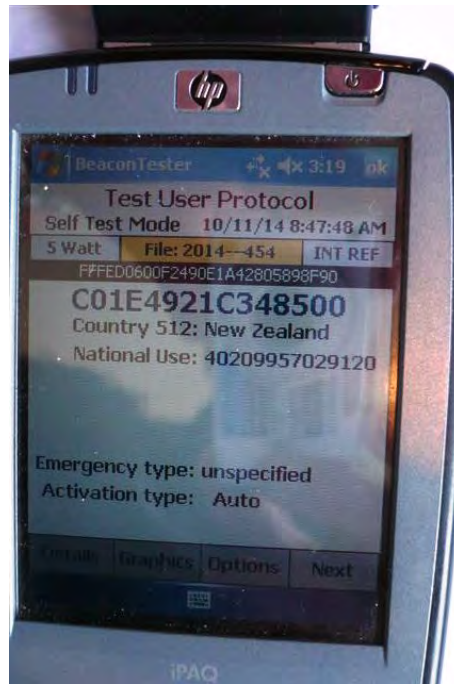
Test 03 2014-454

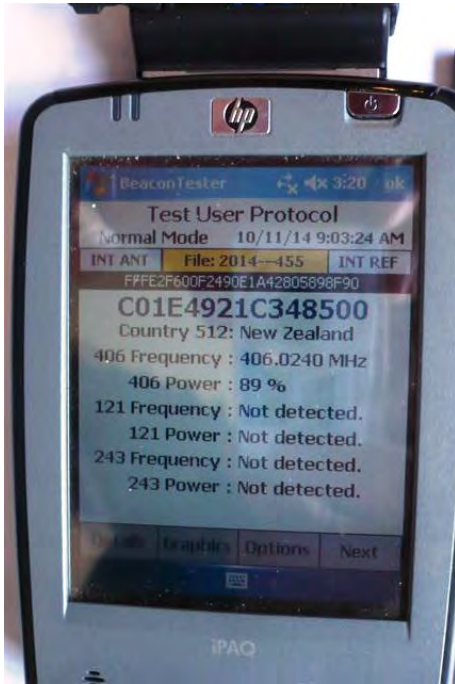
**Test 03 2014-455 = 89% Power
Test taken underneath tail boom**

Internal antenna test 2014-455 under tail boom power measured 89%

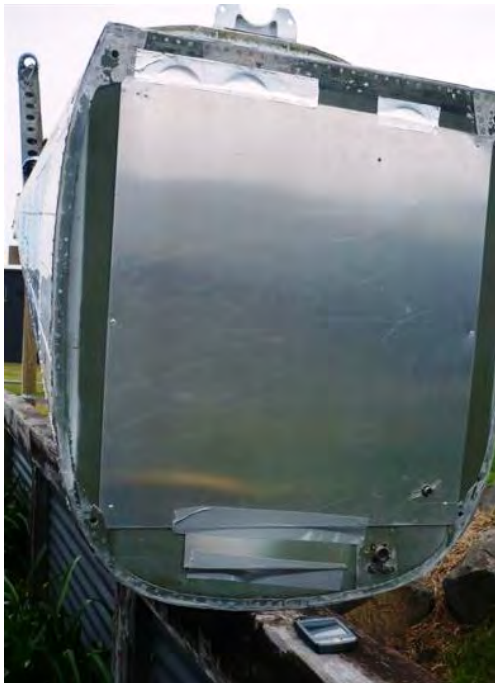
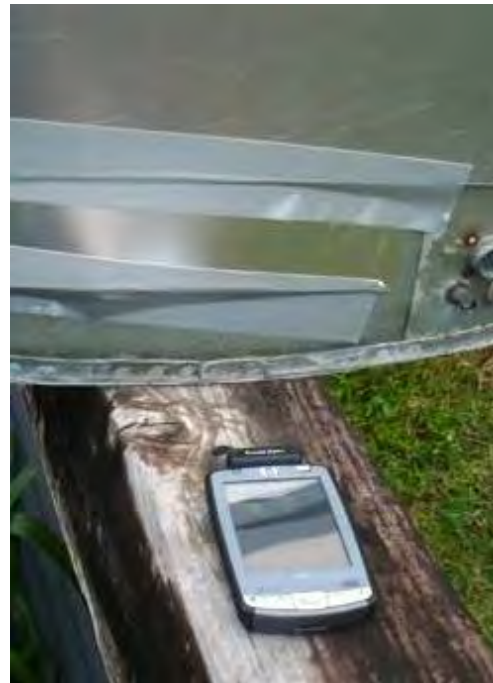
Radiated power Test 03 2014- 453 = 74% Power outside of tail boom

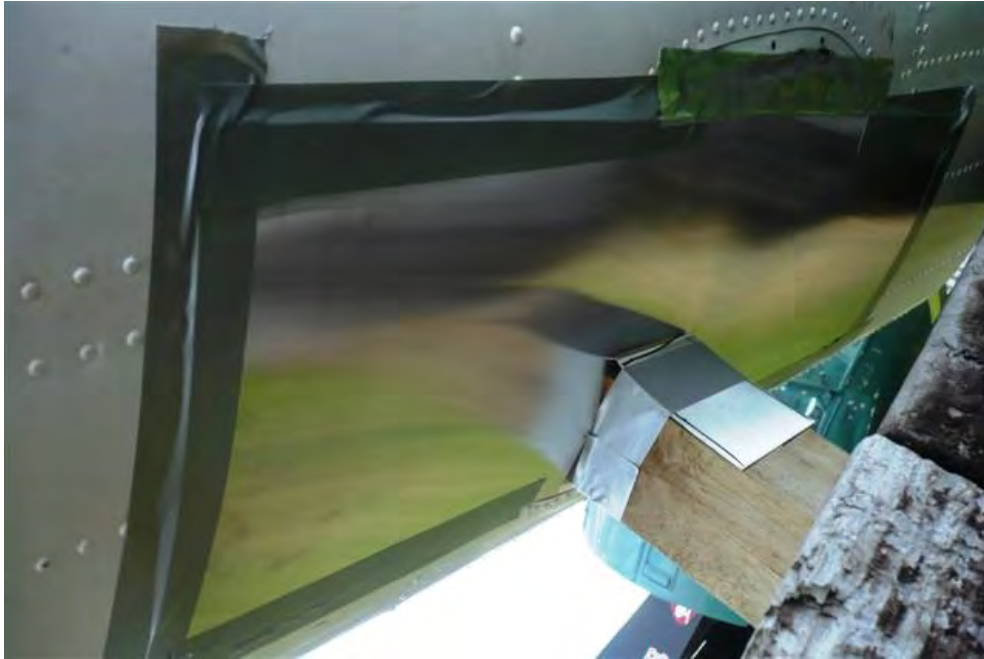
Port covered during TEST 02 and most of Test 03

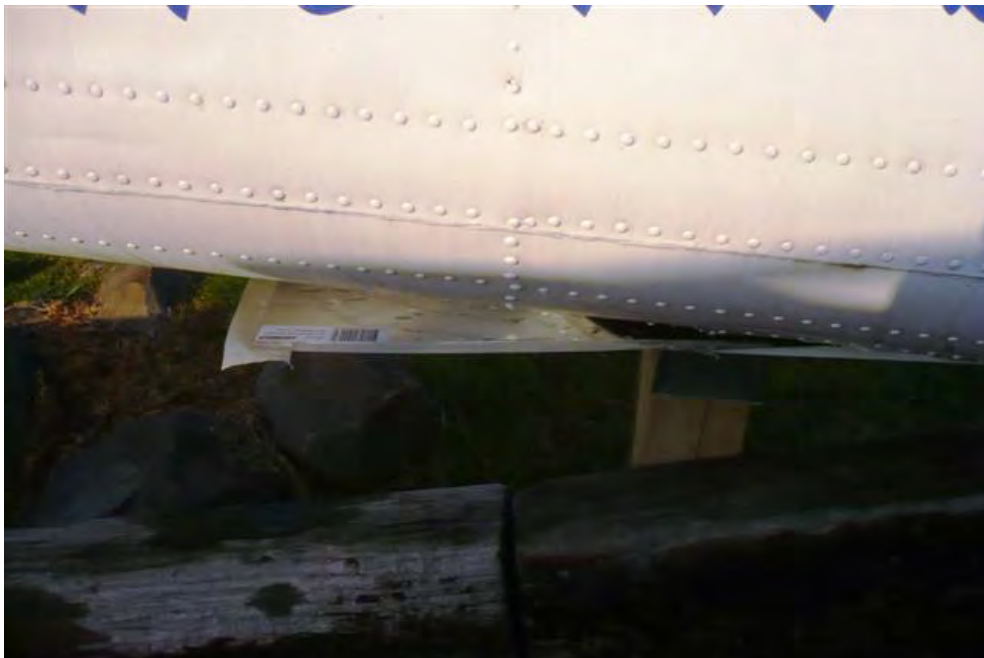
**Duct tape came undone sometime during 24 hour test of Test 03
(as it is on the underside of antenna unlikely to influence test)**

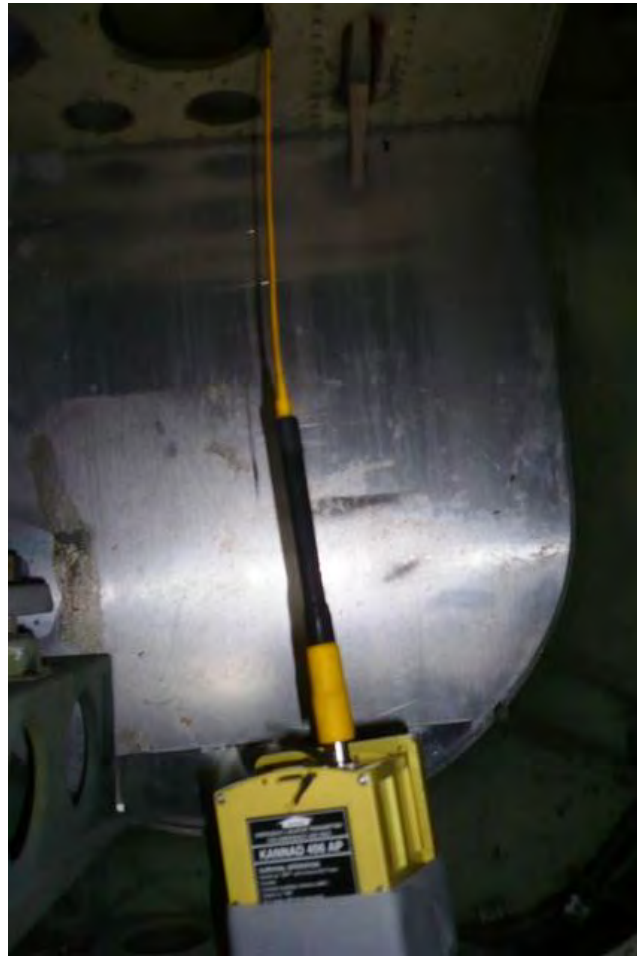
Test 02 Vertical within tail boom

ELT with integrated antenna located inside Tail boom with antenna vertical

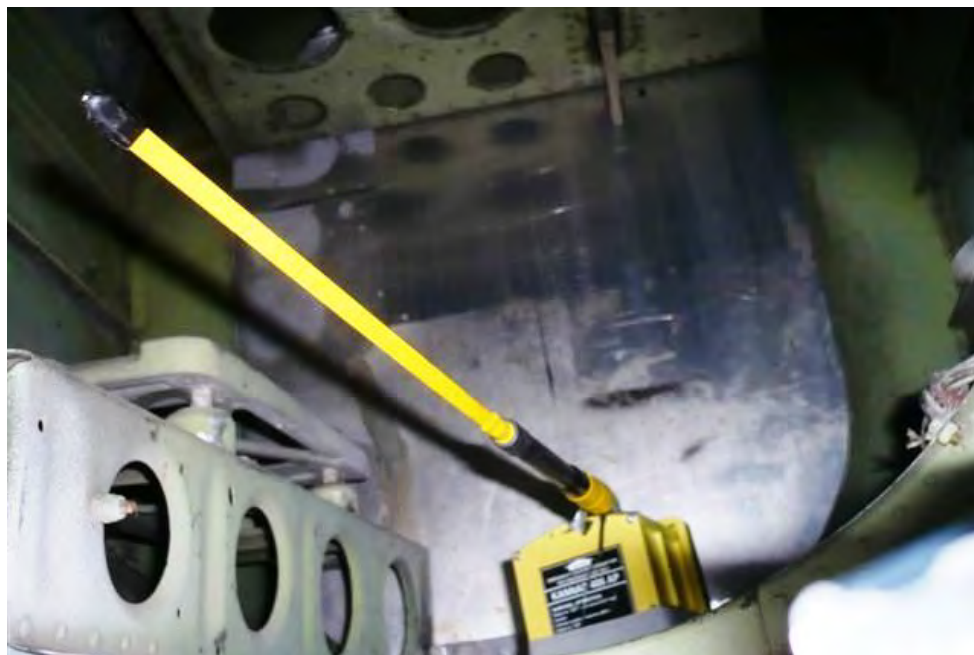
TEST 03 Horizontal antenna within tail boom

ELT with integrated antenna located inside tail boom with antenna horizontal lengthwise within

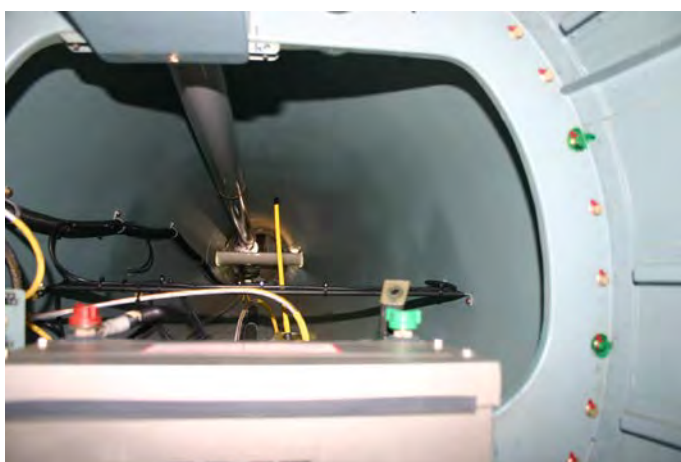
Inside Tail Rotor boom, structure is Aluminium and Nomex; the antenna is visible behind battery box

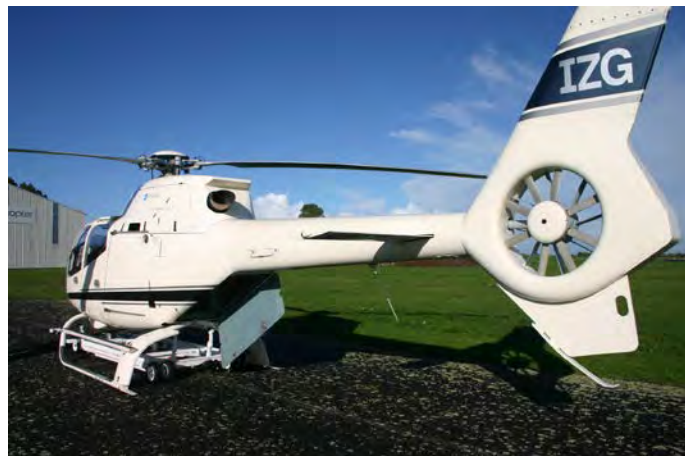
External showing tail boom access

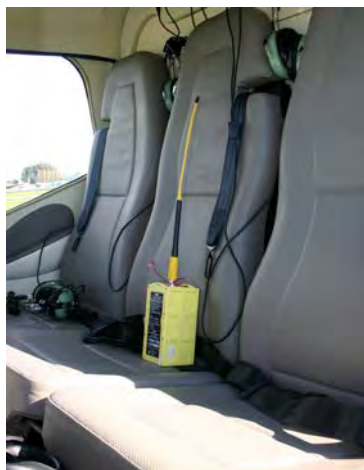
Third serial, the cabin is composite structure including carbon fibre cloth and Nomex

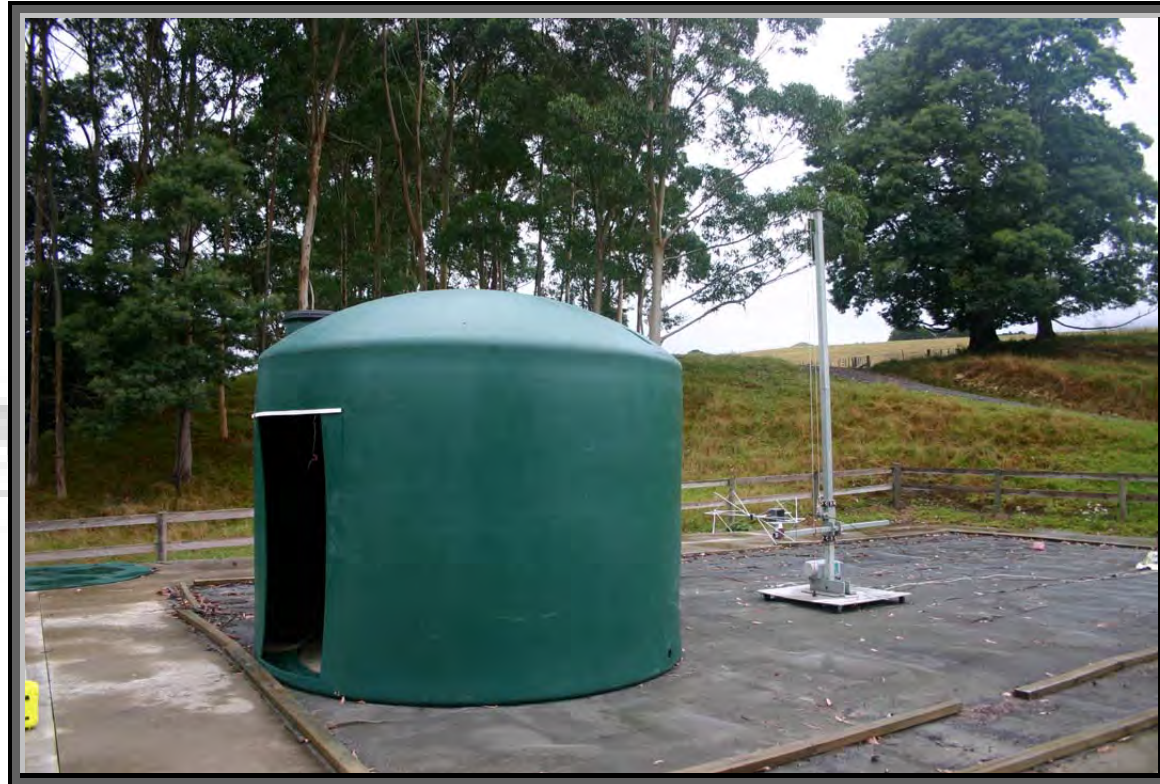
Test setup, table inside green tank, power receiver to right (NZ local time 1005Hrs)

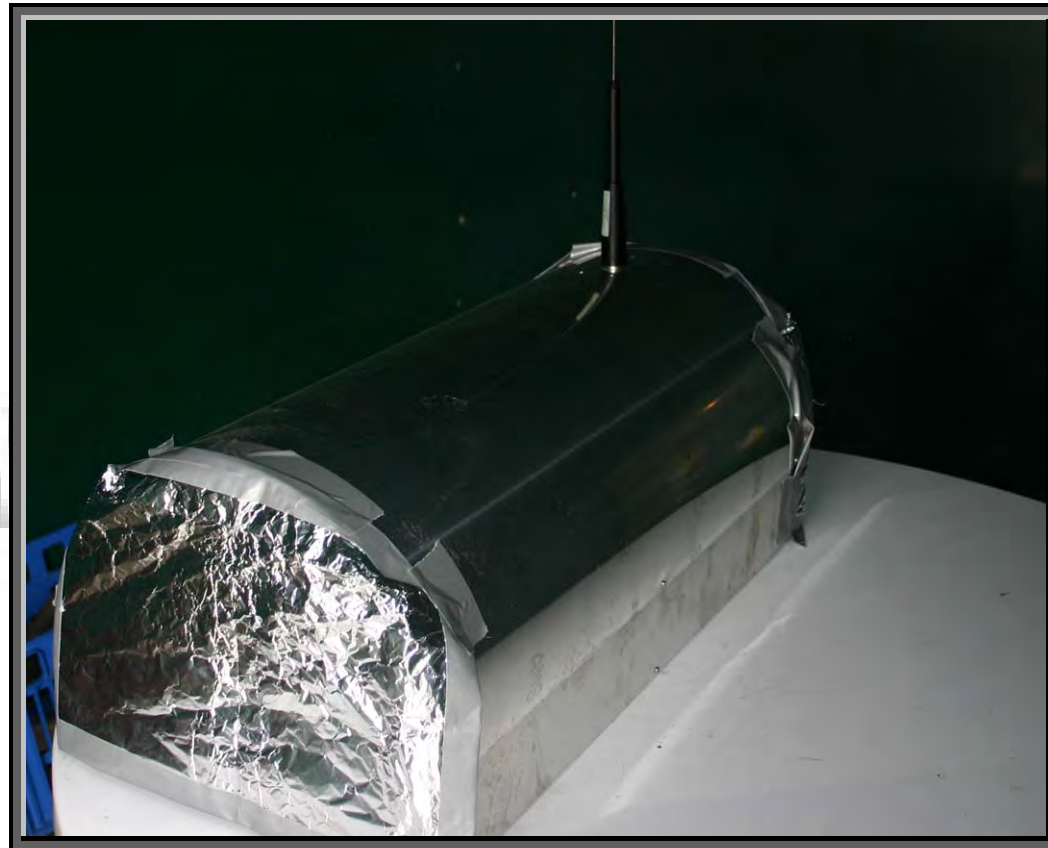
Fully Enclosed setup (NZ local time 1108Hrs)

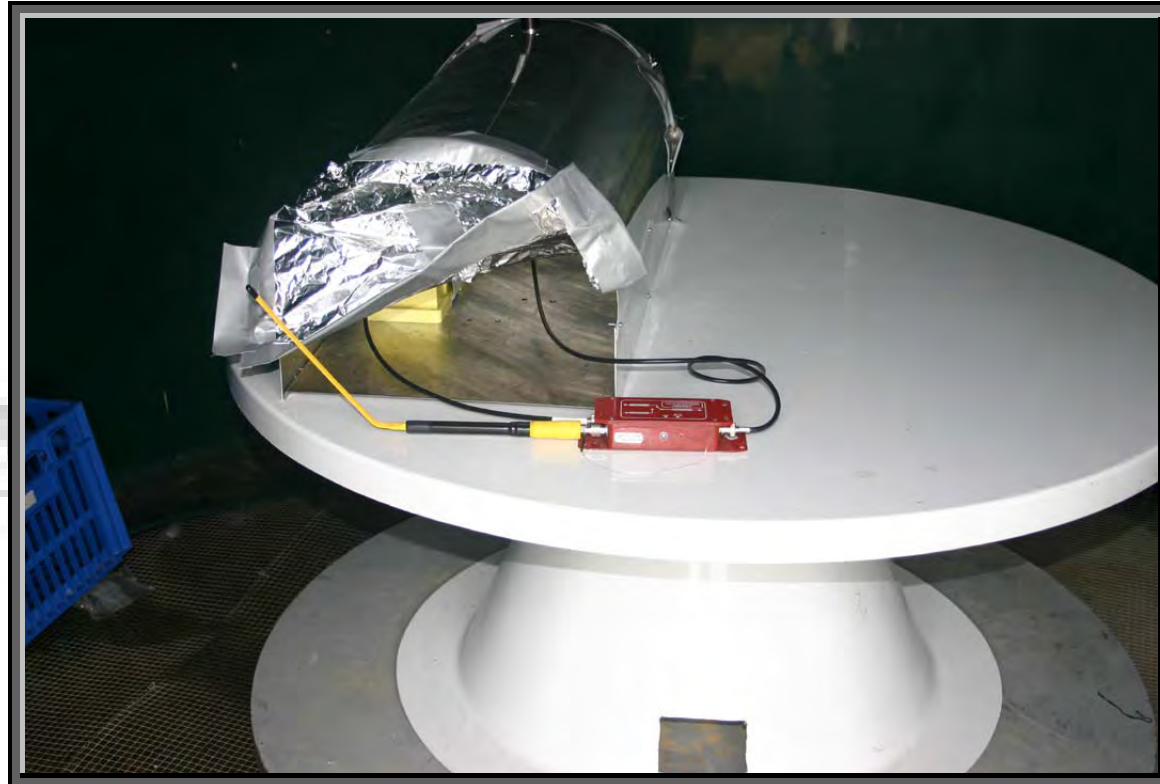
Final test enclosed ANT110 (NZ local time 1139Hrs)

- **Test # 4 (DONGLE KTEST 03) (C01FE870D2135D1)** Note change of HEX Code than that originally advised. Enclosed SASD in structure with the ANT110 antenna connected. Note that the antenna was horizontal then bent thru 90 degrees to fit enclosure. Primary Antenna transmitted at 1140 and SASD was switched at 1145. The test finished at 1200. This was an enclosed test.
- **CONCLUSION Tests show that an enclosed SASD as tested will provide a satellite alert on both the GEO and LEO Cospas-sarsat satellites**

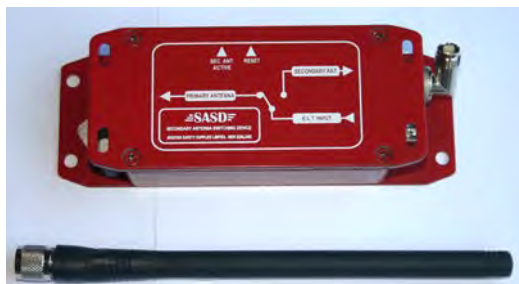
SASD with ¼ wave antenna

Type Number: 15-56-0002		Units
Operating Frequencies	406.025/028	MHz
	121.5	MHz
	243.0	MHz
Insertion loss, input to main antenna port	0.25	dB
Insertion loss, input to alternative antenna port	0.25	dB
SWR all frequencies	1.1:1	
Reverse isolation at 1 metre		dB
SWR detection level (adjustable)	3:1	
Activation delay first burst	5	ms
Activation delay subsequent bursts (locked)	0	ms
Power source - internal	9	volt
Current supply – not active	0	mA
Current supply - active	30	mA
Endurance - active	>24	Hrs
Battery expiry shelf life	5	years
Connector type all ports input /output (ELT)	BNC	female
Connector type back up antenna	TNC	mm
Antenna ¼ wave 406/121.5MHz		
Environmental standard to be approved	C126	TSO
Fail safe mode (electrical or battery fail) default to connection	Main antenna.

Dimensions SASD 170 x 60 x 35 mm (270grams)
Secondary Antenna 210mm long including TNC connector (53grams)
SASD Fitted preferably in line with ELT on the same structural member.

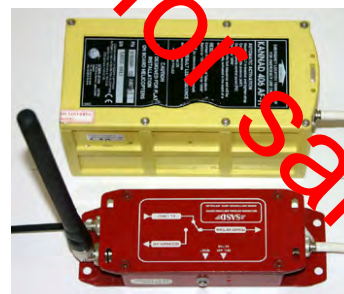
SASD with 406AF-H ELT
