# 406MHz ELT's and 406MHz Antenna's

Lloyd Klee  
[www.aviationsafety.co.nz](http://www.aviationsafety.co.nz)

# Reasons as to failures

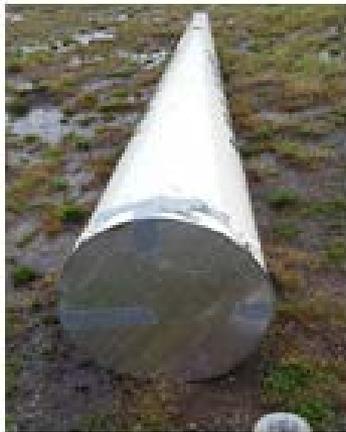
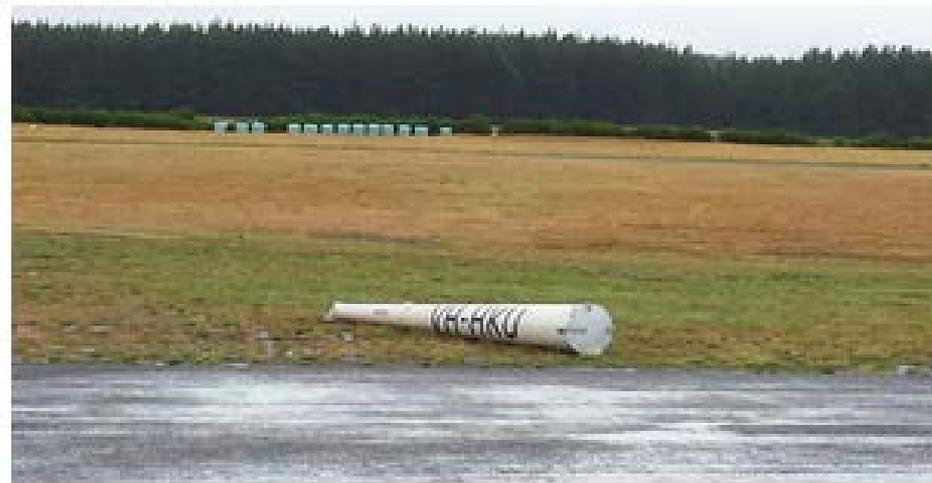
# Testing an antenna within a Tail Boom – R44

## Test location Taupo

- Check BT100 2015- 043
- Power measured BT100 = 35.2dBm
- Power receipted on GEO satellite
- -134.55 dBm average
